Test Report No. : USA00017767
Report Date : July 18, 2018

TEST REPORT

Product Name : 1" Vinyl Mini Cordless White
Style/Model # : MLX2360WH
Size : 60in (L) x 22.5in (W) x 2in (D)
Supplier : Lotus & Windoware, Inc
Sample received date : July 10, 2018
Date of testing ended : July 17, 2018

SUMMARY
The testing is performed on Window Coverings for the WCMA "Best For Kids Program" per standard ANSI/WCMA A100.1-2014; it may have no cord or may be tested per Appendix C or Appendix D of the standard based on cord configuration. This report will only state if the specified criteria is met for the tested product. This report does not provide certification or authorization to use the "Best for Kids" logo.

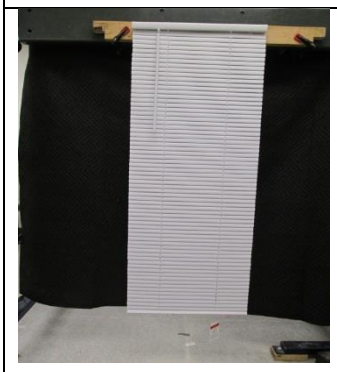
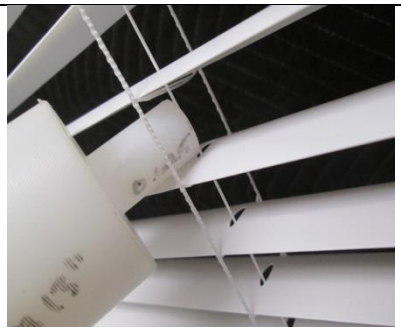
As Received

Fully assembled	Appendix C	Appendix D
